## M2A1 Machine Gun, Caliber .50

### Barrel Installation:

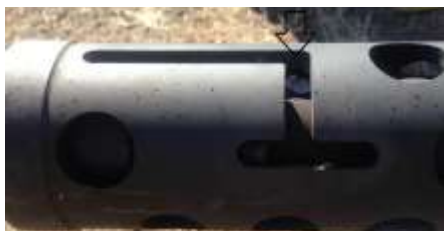
Picture 5

Failure to properly install the M2A1 barrel into the barrel extension will cause the weapon to malfunction and damage the barrel assembly by shearing the barrel alignment guide pin off of the barrel. Once the barrel alignment guide pin is sheared off, the barrel is non-repairable and the unit must then buy a replacement barrel for a cost of \$1,741 per barrel. The costs associated with replacing the damaged barrels so far have been approximately \$30,000 to date.

Picture 5: M2A1 barrel alignment guide pin is sheared off due to improper barrel installation.

When installing the barrel into the M2A1 receiver, barrel installation procedures must be followed in accordance with TM 9-1005-347-10 (WP 0023 00-3 and WP 0023 00-4). Failure to adhere to the steps in sequence will result in weapon malfunction, damage to the barrel assembly, and/or the M2A1 receiver.

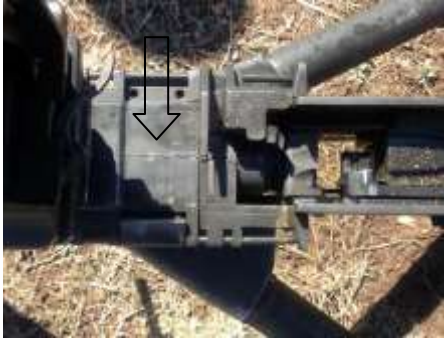
Picture 6

Picture 6: The cracked M2A1 receiver is the result of pressure from an unsupported ammunition cartridge due to improper barrel installation.
