DEPARTMENT OF THE ARMY
UNITED STATES ARMY EVALUATION CENTER
2202 ABERDEEN BOULEVARD – SECOND FLOOR
ABERDEEN PROVING GROUND, MARYLAND 21005-5001

8 January 2015

SUBJECT: Safety Confirmation for the 155mm M284 Cannon Tube Bore Evacuator Hole Repair Process Provided for Fielding

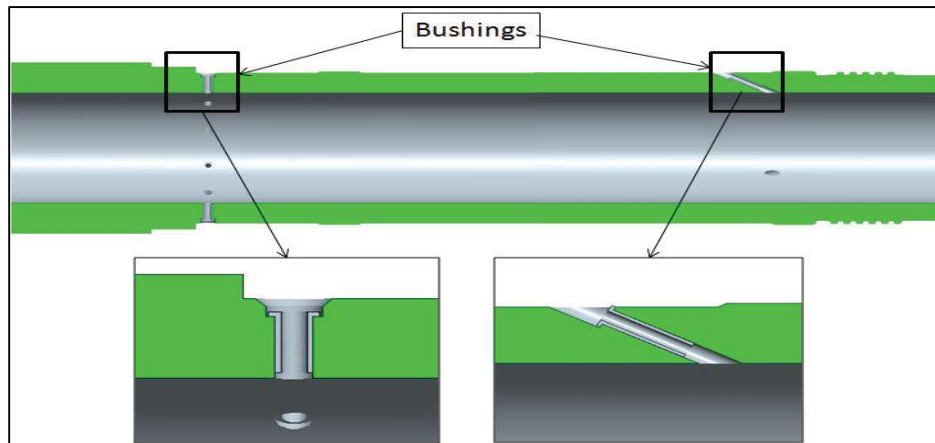
(2) Restore Bore Evacuator Hole Size. To insure the bore evacuator performance was not degraded, the bore evacuator holes had to be brought back to their original diameters. This was done by inserting a bushing into the hole (Figure 1). The bushings were inserted using an overstraining process, similar to the autofrettage process used to increase the strength and fatigue life of gun tubes. The process permanently sets the bushings in place and also imparts favorable compressive residual stresses into the bushing and gun tube. The compressive stresses prevent environmental stress cracks from forming in addition to increase the fatigue life.

Figure 1. M284 Cannon bore evacuator holes with bushings.

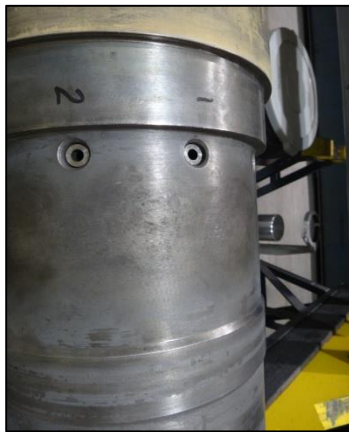
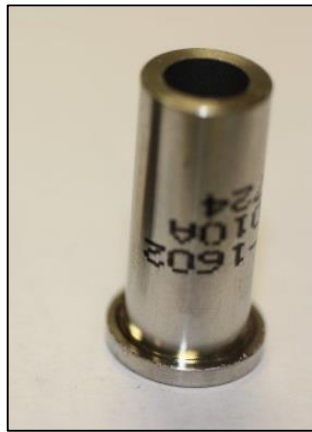
(3) Prevent further Corrosion. The bushings used in the bore evacuator holes are made from PH 17-4 stainless steel (Figure 2) which has a far higher corrosion resistance than standard gun steel and are expected to prevent future corrosion in the bore evacuator holes.

Figure 2. M284 Cannon bore evacuator holes and bushings.
