SAFETY ALERT

Locally Fabricated Towing Device

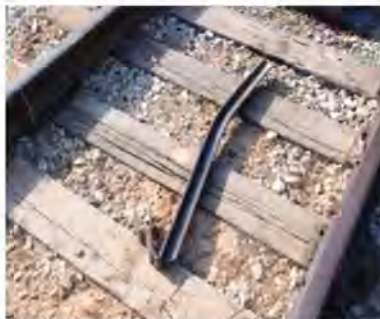
Accident Tow Bar

The investigation is in its initial stages but the Board has identified concerns with the role of a locally fabricated towing device in the accident. While the board's conclusions are not final, there is sufficient reason to be concerned that similar tow bars in use across the Army may present an immediate risk to personnel and equipment. With no specific standard currently available to inspect these devices, I recommend the use of all improvised or non-certified towing devices be halted until the investigation is complete and the board can make recommendations that are more specific.
