WHITEPAPER**BFVS AGM Battery Investigation**

October 3, 2014

BAE SYSTEMS
Vehicle Systems Division
Santa Clara, CA 95050

This whitepaper serves as the final report for Problem Investigation (PI) MCA-111-P25R1.

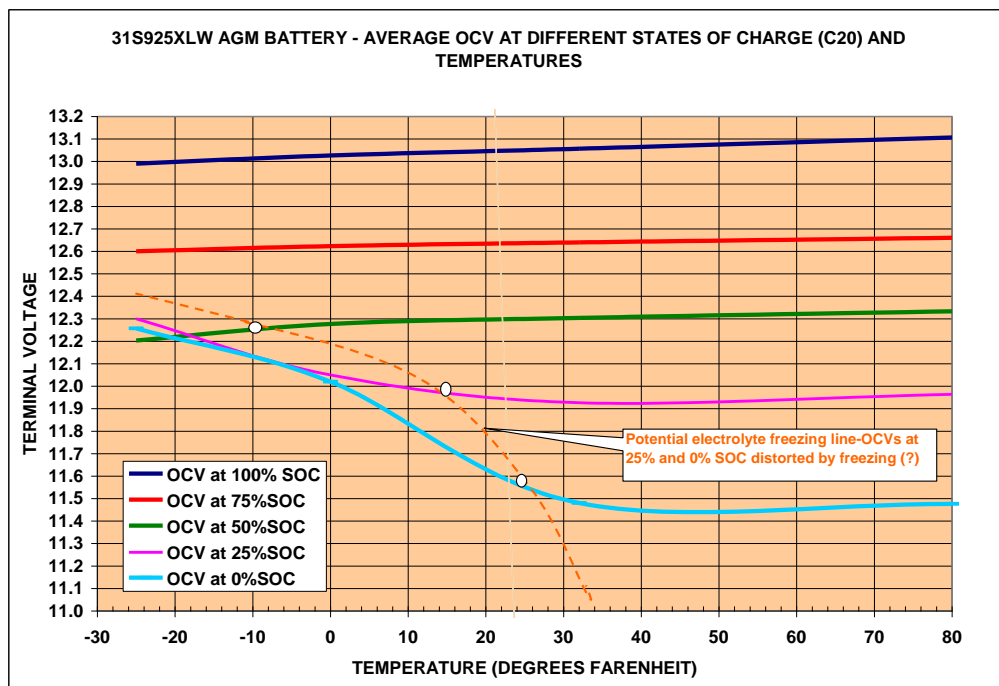
Figure 5 Exide 31A925XLW VOC vs. Battery Temperature (with freeze line)

- a. Charging in cold climates was required between operational periods to recover batteries that were “dead” after storage (monthly).
- b. The lack of battery failures, despite the cold, suggest that the maintenance team was able to keep the batteries unfrozen [i.e., charge greater than 75% SOC (battery electrolyte for fully charged battery freezes at ~-100 °F, while a completely discharged battery will freeze at temperatures as low as 25 °F; see figure 5, below)]. The formation of internal ice in the electrolyte can physically damage the tightly spaced plates, glass mat and separators.

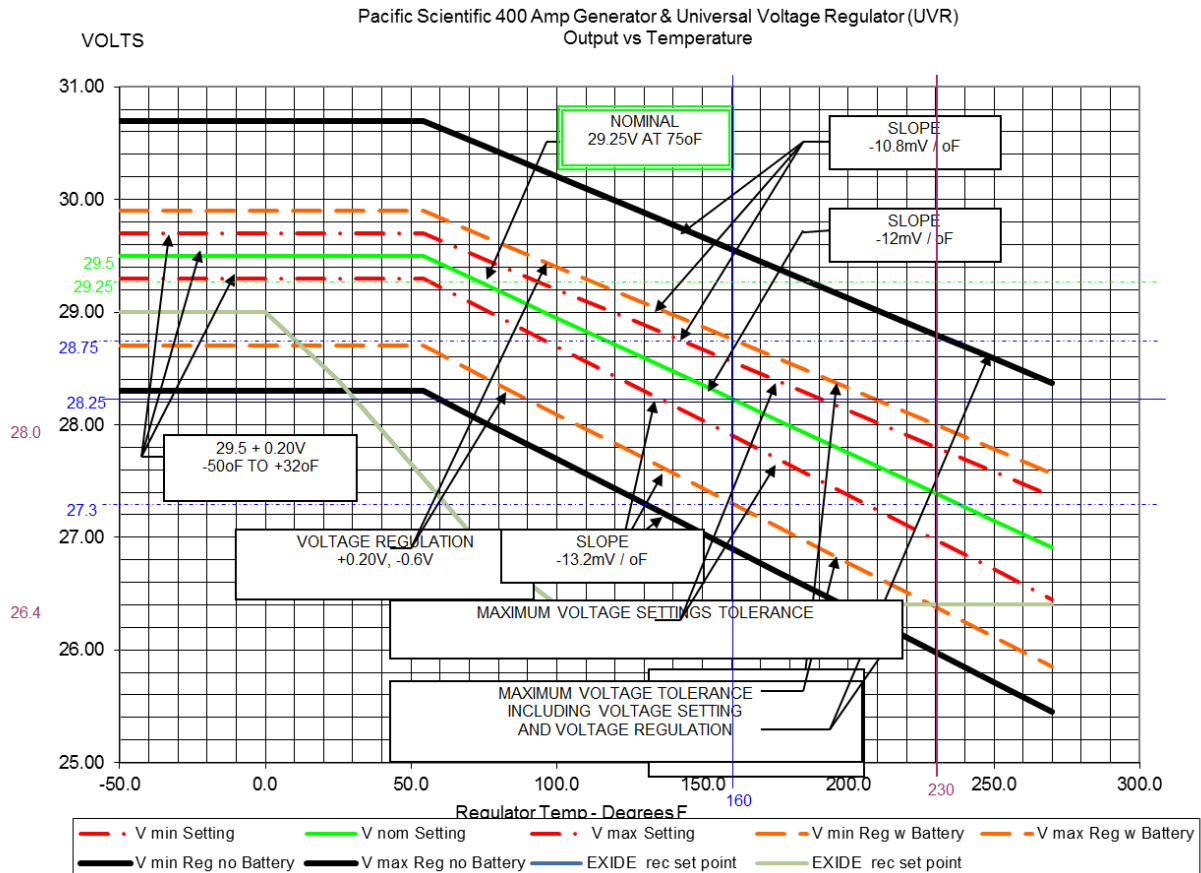
Figure 6 A3 BFVS Output Regulator Curve

- c. Note that an AGM battery, unlike a flooded cell battery, cannot replenish the lost electrolyte. Given the high incident of AGM batteries being removed from service, the last factor, overcharging, which is typically a function of the regulator set point received further study. The battery OEM recommends a charging set point of 28.4 +/- 0.3 V for a bus supported by two batteries in series (at battery temp of 25 °C). Figure 6 provides Pacific Scientific/CE Niehoff regulator voltage output as a function of temperature.

Thus at start, the voltage set point is approximately 1 volt higher than the recommend float voltage. As the regulator temperature (located in the engine compartment) rises, the voltage decreases until it settles in the recommended range. This open loop relationship for engine based recharge over time achieves the desired set for the nominal battery temperatures. But the lack of data to validate that this relationship is valid leads to a recommendation that the actual battery temperature be measured, via a Battery Monitoring System (BMS), and used by the regulator to eliminate charge voltage uncertainties. This vehicle voltage data was presented to Exide during development of the 31A925XLW and their engineering staff felt this charge compensation was adequate for their battery.

3. Temperature compensation of battery charging. The generator charging voltage should be set according to sensed battery temperature not engine compartment temperature in order to meet the battery manufacturer's charging profile. Similarly, the cart based charging could benefit as the current the PulseTech PRO-HD charger has no means of adjusting battery charge voltage based on temperature.

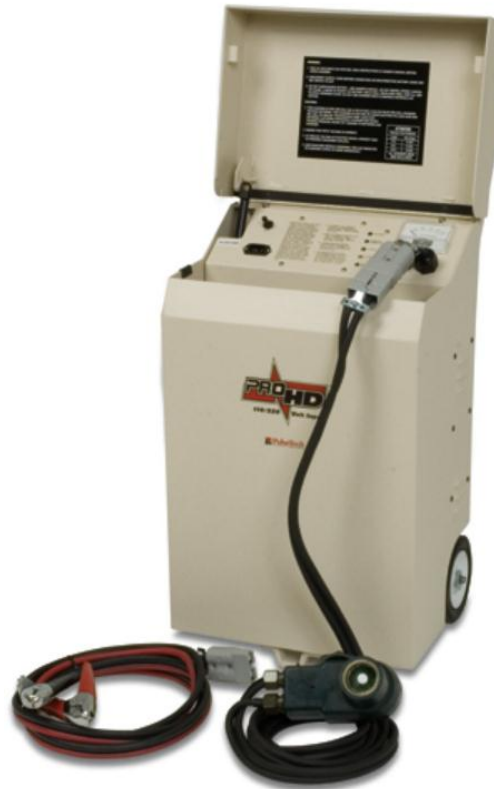
Figure 7 PulseTech PRO-HD

- b. There is lack of evidence that the use of the TARDEC “PulseTech PRO-HD” designed charge system is recovering batteries.
- At 45 A peak output, the charger is be under powered to effect charging of the four battery strings in the presence of parasitic vehicle loads in a timely manner.

- Charger performs no temperature compensation of the charge voltage that is recommended by all AGM battery vendors. This may be a contributing factor to overcharge casualties in hot environments.

2. Use a higher current battery charger to affect battery charging in the vehicles in a timely manner via the NATO slave. If high output chargers are not available consider isolation of the batteries from the always on system loads to effect timely charging.
