# VIGNETTE #1: BACK LAY

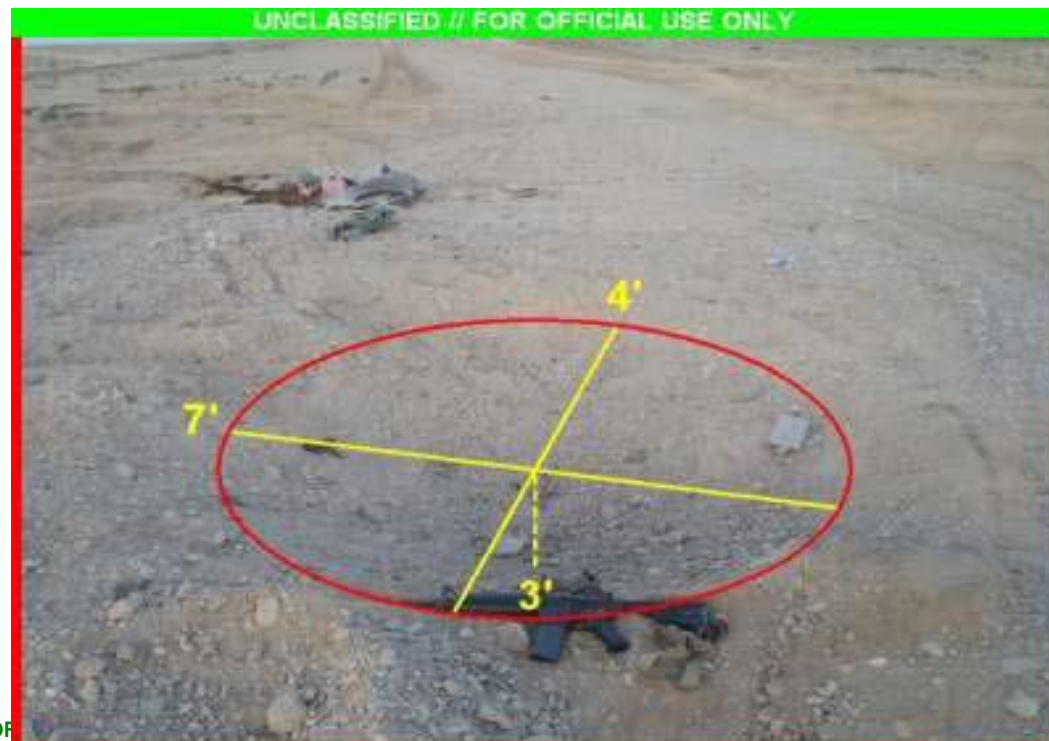
- A Husky struck an IED in a wadi while sweeping for secondaries from a prior find and post-blast analysis. EOD Team Leader cleared a path to the vehicles and extracted casualties and directed them to the rear of the convoy. Blast seat measured 7' x 4' x 3'. Team Leader assessed main charge at 80 lbs of UBE.
- Wadi provided restricted terrain. Anti-CF have been known to use natural choke-points as a hotbed for IED emplacement in this area.
- No IPB was conducted.
- This wadi was back-laid after previous RCP clearance.
- No ISR or CA support on this patrol
- Constant over-watch on a cleared route was recommended as a result of this strike.

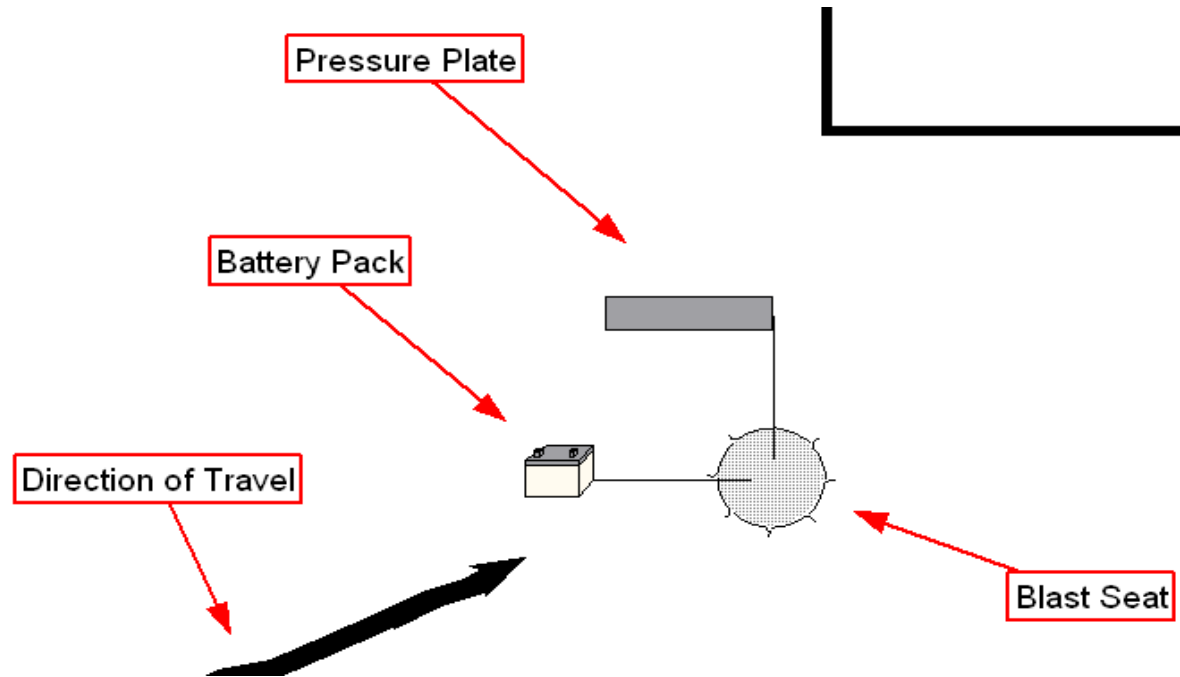
# VIGNETTE #2: V-SWEEP, PARTNERED

RCP with EOD was clearing a route when one of the partnered dismantled v-sweepers triggered an IED resulting in 2 x CF WIA. Lead sweeper found a high signature with his CMD metal detector. An engineer moved up to interrogate the area when 2 dismantles (1 x ANA, 1 x US) walked off route to investigate another suspicious area. While US was interrogating, ANA stepped on a pressure plate initiating the IED. EOD Team Leader and Team dismantled the vehicle, met up with the medic and swept to the site, cleared a site around the wounded and began administering aid. EOD TM stayed with the wounded to assist the medic while the TL cleared to recover lost sensitive items and perform PBA. TL located 1 x 4 D-Cell battery pack, 1 x HMS pressure plate, and fragmentation consistent with an 81mm US illumination mortar. Main charge estimated at 10 pounds ANAL.

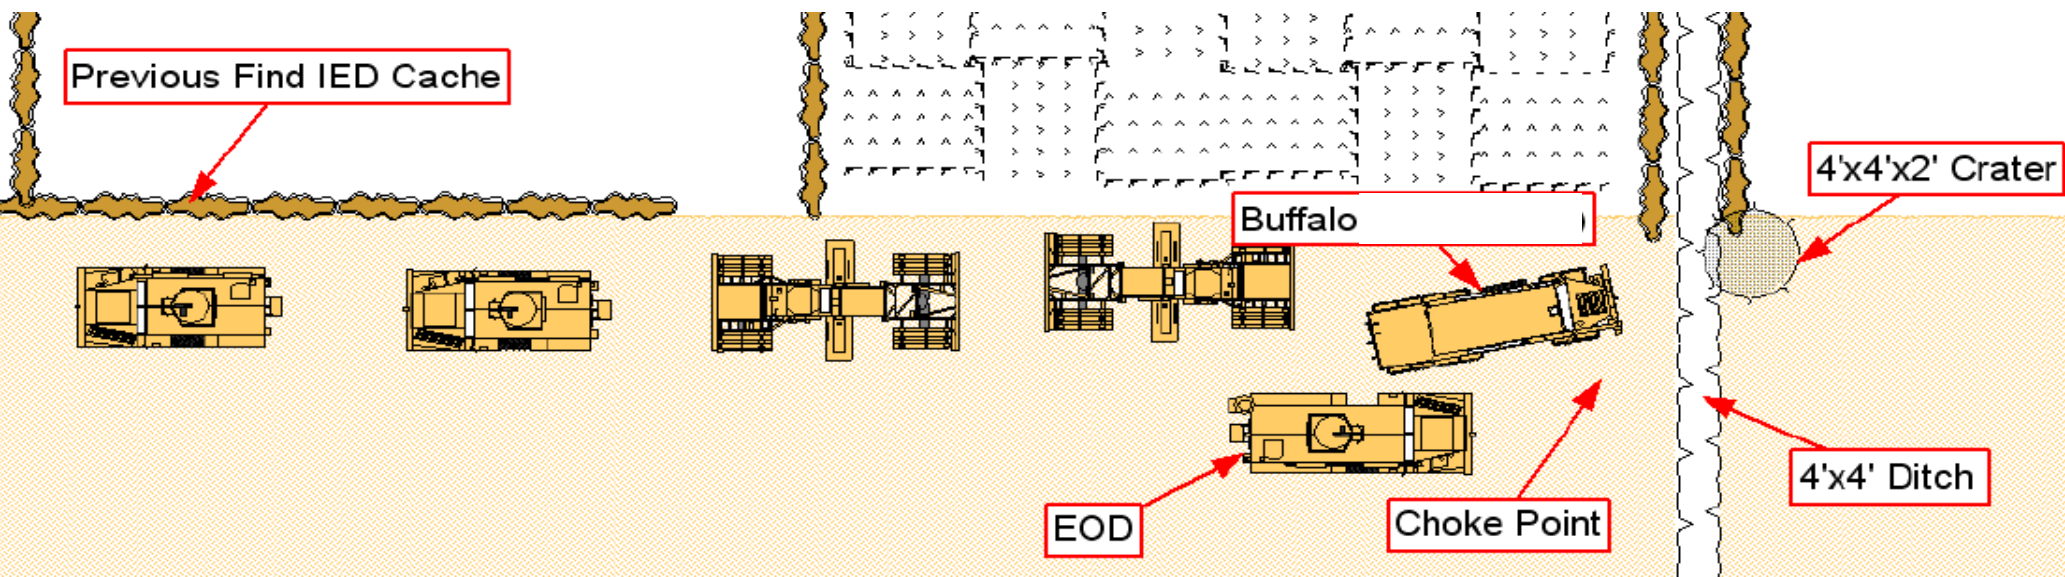
# VIGNETTE #3: BACK LAY

- While conducting mounted route clearance the lead Husky noticed disturbed earth near a wadi crossing area (4' X 4' Ditch) and called for the Buffalo to interrogate. The patrol used the crossing an hour prior, but did not have overwatch on the route. A stack of rocks was used as a marker. Detonation of the IED occurred during interrogation causing minor damage to the Buffalo arm with no casualties.
- RCP was clearing as an individual unit. There was no ISR or CA in support of patrol. There was no overwatch.

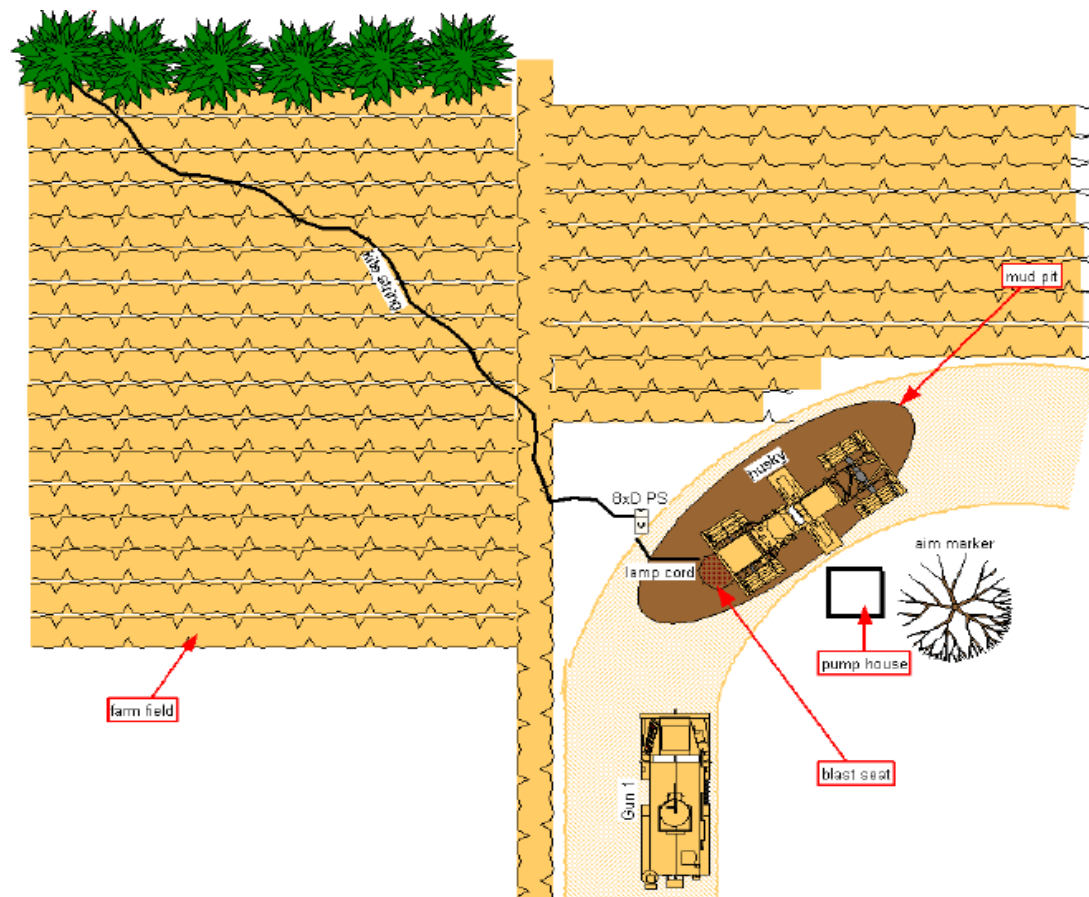
# VIGNETTE #4: FRONT LAY

- An RCP unit was halted for approximately 2 hours for mine roller recovery. When mounted route clearance continued, the lead vehicle (Husky) struck an IED a few kilometers down the road. 8 D-cell batteries, a lamp cord, and a kite string were recovered. A command wire leading to bushes was located. Insurgents had gathered women and children by the bushes to protect themselves in the event CF identified the trigger man. The main charge was located in a puddle of water. The unit leader believes insurgents observed the mine roller recovery and placed the device ahead of the convoy.
- No IPB was conducted of the route beforehand. No intelligence products were requested or provided. RCP was clearing with no support; No ISR or combined arms in support of movement.

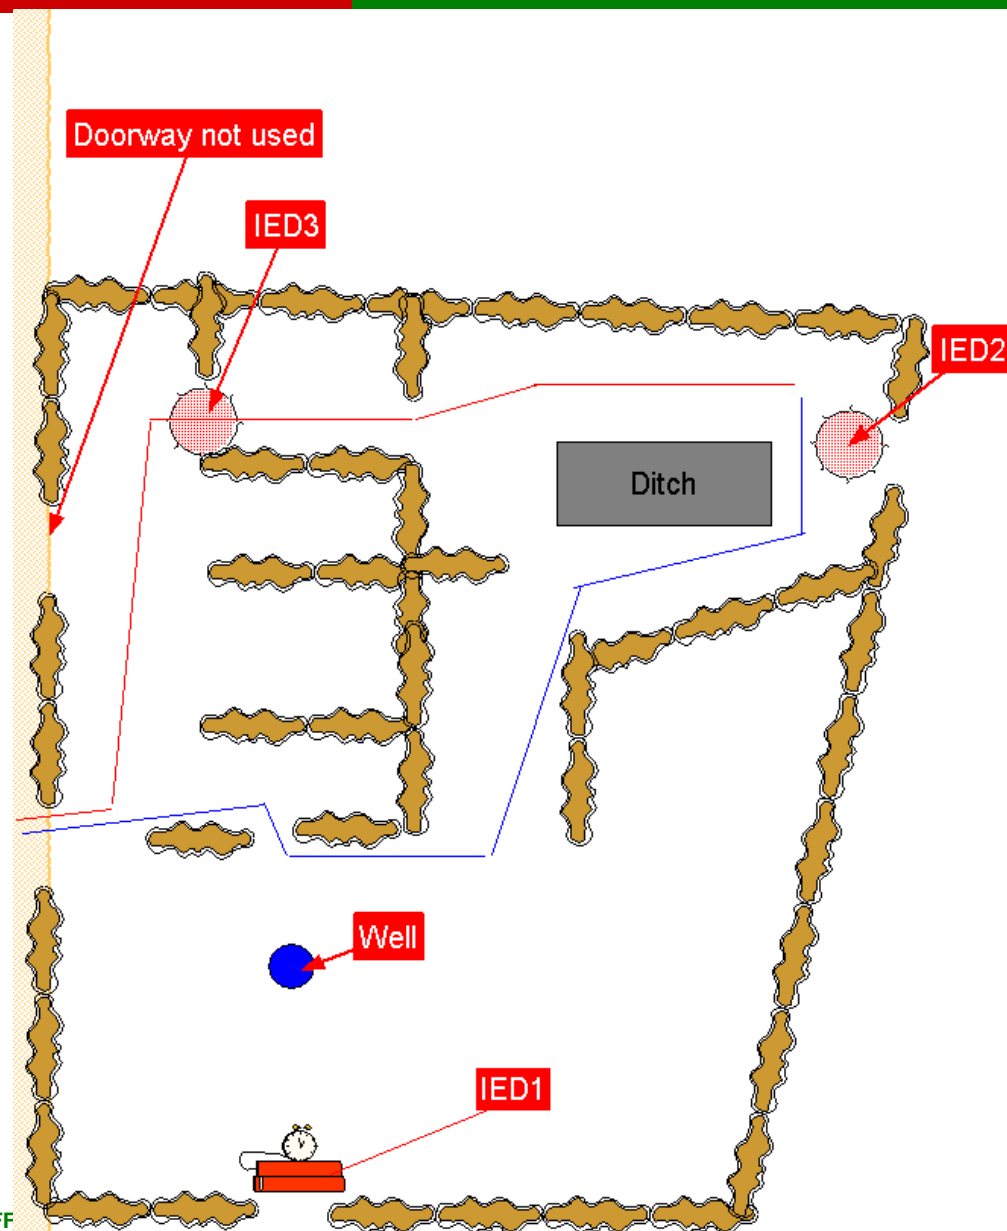
# VIGNETTE #6: DISMOUNTED CLEARING

- While conducting dismounted clearing, 2 IEDs were located in a compound – IED 1 and IED 2. EOD was shown IED 1 and placed an excavating charge. The charge uncovered a pressure plate, battery pack, and exposed a jug containing ~5 lbs UBE. A sweep team continued to clear the building with HDDs following the path depicted in the blue line while EOD detonated the main charge in place. Immediately following EOD's detonation, they heard an explosion in the NE corner of the building (IED 2) resulting in 2 WIA. The IED consisted of ~20lbs UBE; 2 x 9v battery pack was later found next to the crater. A second dismounted sweep team entered the building but made a left, depicted on the red line, and proceeded down the hallway. As the sweeper knelt down and began to dig with his knife to confirm IED 3, it exploded resulting in 1x KIA and 8x WIA.

- Ground Sign Awareness, application of the 10 principles of CIED, and assumed secondaries are key lessons learned from this vignette.
