BASED ON RECENT MORTAR MALFUNCTIONS AND MISHAPS AMMUNITION BEARERS SHOULD PAY SPECIAL ATTENTION TO THESE POTENTIAL PROBLEM AREAS...

PS 753 38 **AUG 15**

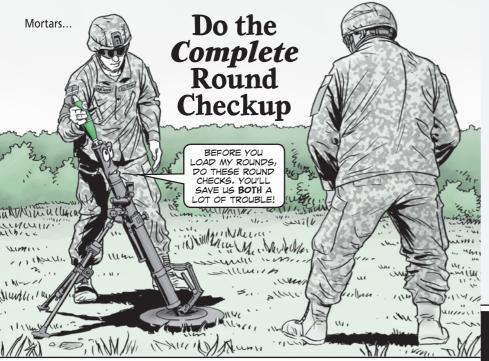
IT'S THE RESPONSIBILITY OF A MORTAR CREW'S AMMUNITION BEARER TO INSPECT MORTAR ROUNDS BEFORE THE ROUNDS ARE FIRED.

CHECK THE FIN BOOM FOR BENT FINS (OTHER THAN THE NORMAL CANTED FINS ON THE BOTTOM OF THE FIN BLADES).

INSPECT THE PROPELLING CHARGES FOR LEAKING PROPELLANT. IF YOU FIND BLACK POWDER ON OR AROUND THE PROPELLING CHARGE AND IN THE FIBER TUBE PACKAGING, REPACK THE CARTRIDGE AND RETURN IT TO THE AMMUNITION SUPPLY POINT (ASP).
