MAY-JUNE 2012

ARMY SUSTAINMENT

The Three Most Common Electrical Safety Issues in Deployed Environments

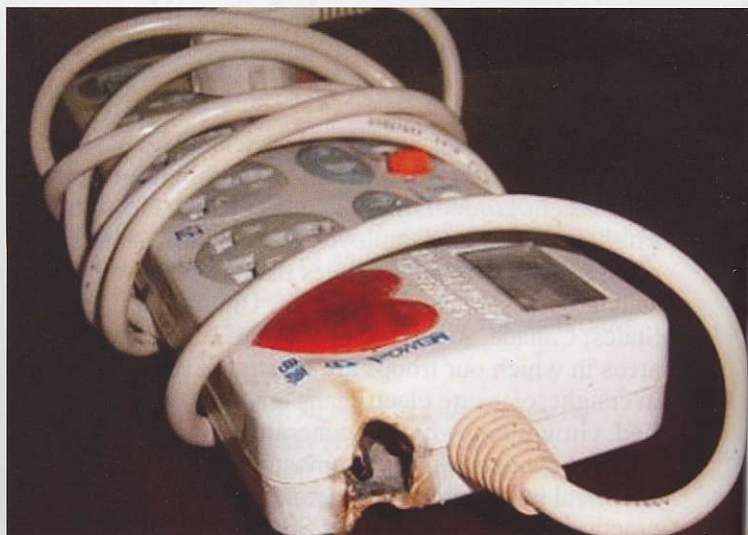
Stripping wires and putting them into outlets is a common method of bypassing adapters. It is illegal and extremely dangerous.

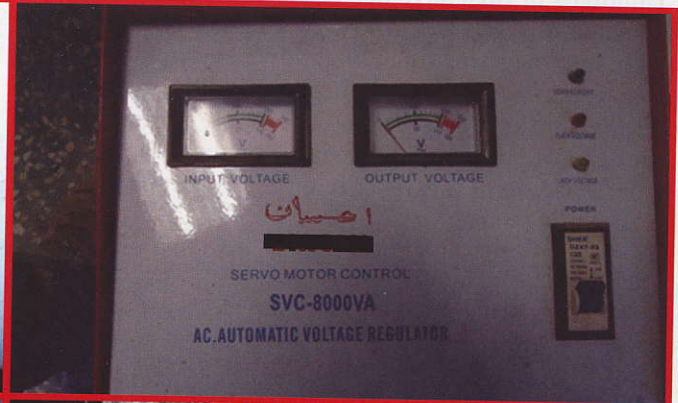
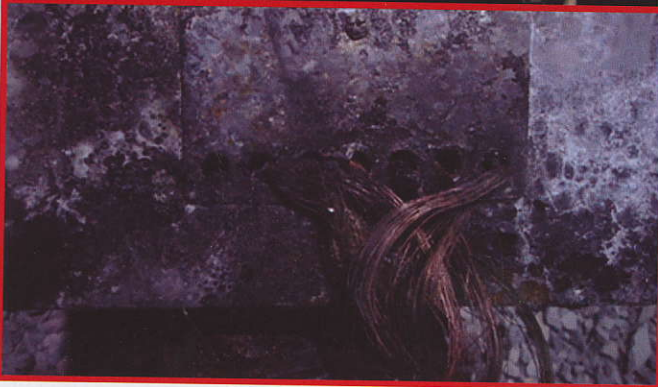
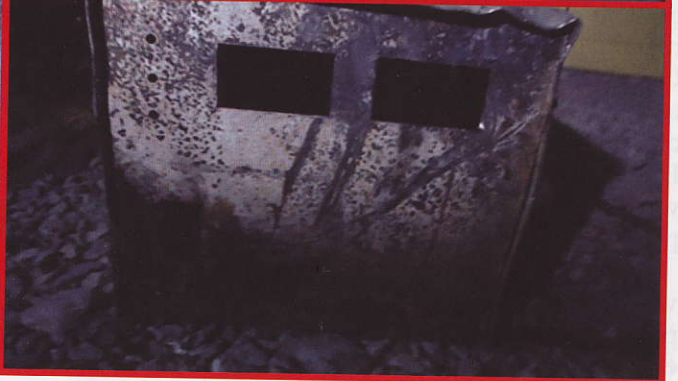
This non-CE certified step-up/down voltage transformer and regulator was the cause of a fire at an operating base in Afghanistan. Procuring safe transformers is difficult since most are not CE approved and many have counterfeit CE logos applied by Chinese manufacturers.

Step-up/down voltage transformers provide a solution, but the primary source for these appliances is—you guessed it—China. After electricians employed by a U.S. contractor in Afghanistan inspected new locally-purchased step-up/down transformers, they were determined to be unsafe. Manufactured in China,

they included a counterfeit CE logo carefully stenciled on the side. A visit to the company website revealed a link to the CE certificate—a handsome piece of paper with fancy script suitable for framing. It was counterfeit; there was no CE approval.

When an electrician checked the transformer schematic posted on the website, he determined that the ground was insufficient and the product presented a serious fire and shock hazard. A Google search for “unsafe Chinese transformers” reveals a wide variety of perspectives, with most experts advising caution when purchasing Chinese electrical products and many highlighting the widespread counterfeit certification problem.

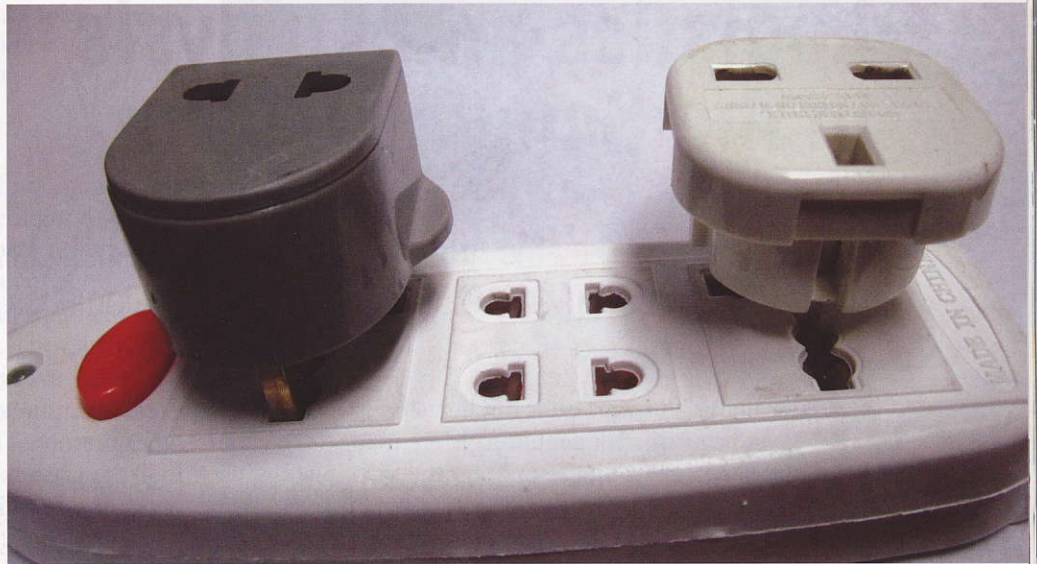
Chinese power strips are often poorly constructed and easily catch on fire. However, their multiuse outlet configurations make them very appealing. They are not UL or CE approved and are not allowed on U.S. military facilities in Southwest Asia.

The primary source for these unsafe power strips is China. The China Compulsory Certification (CCC) logo is intended to be a quality control standard. However, electrical power strips with the CCC logo have consistently been shown to be of poor quality and often catch on fire. Chinese power strips are usually made of very thin plastic, have internal metal components that quickly loosen with use, and have extremely small wire gauges that are unsuitable for the amperage the strip can draw.

Hundreds of fires have been caused by Chinese power strips. When multiple high-amperage items are plugged in, the strips often melt down and ignite a fire. Chinese manufacturers have become skilled at counterfeiting and applying UL and CE logos, frustrating safety and fire professionals when procurement personnel purchase items locally that appear to comply with the UL or CE standards.
